MOBILE OFFSHORE DRILLING UNIT (MODU) OCEAN RANGER,
O.N. 615641, CAPSIZING AND SINKING IN THE ATLANTIC
OCEAN ON 15 FEBRUARY 1982 WITH MULTIPLE LOSS OF LIFE

1. Report No. USCG 0001 HQS 82		2. Government Accession No. AD-A140 910		3. Recipient's Catalog No.	
4. Title and Subtitle Marine Casualty Report Mobile Offshore Drilling Unit (MODU) OCEAN RANGER, O.N 615641, Capsizing and Sinking in the Atlantic Ocean on 15 February 1982 with multiple loss of life				5. Report Date 20 May 1983

**REPORT OF THE U.S. COAST GUARD
MARINE BOARD OF INVESTIGATION CONCERNING
THE MODU OCEAN RANGER, O.N. 615641;
CAPSIZING AND SINKING IN THE ATLANTIC OCEAN
ON 15 FEBRUARY 1982 WITH MULTIPLE LOSS OF LIFE**

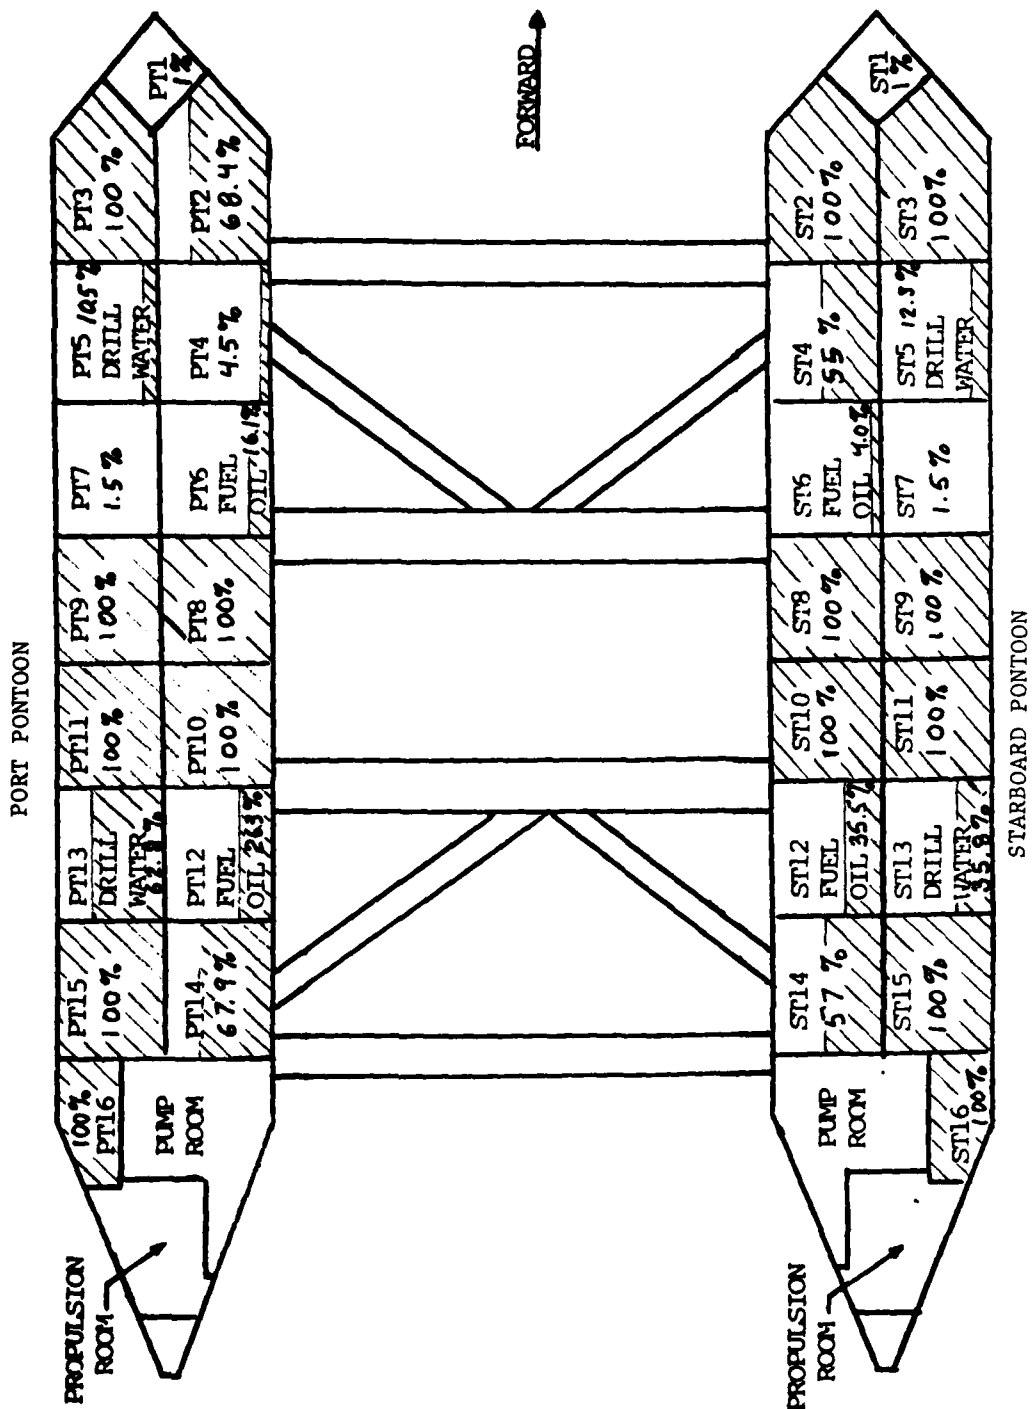
Figure 15: PERCENTAGE OF LIQUIDS IN OCEAN RANGER PONTOON TANKS,
MORNING OF 14 FEBRUARY 1982

Figure 15 depicts the liquid levels in the ballast tanks on 14 February 1982 as indicated in the weekly ballast report work sheets recovered from the OCEAN RANGER. The report indicated that the after ballast tanks used for adjusting trim, PT 14 and ST 14 were respectively 67.9% and 57.0% of capacity. The ullage provided a potential moment to correct trim of 58,000 foot/long tons (F/LT). During the evening, the control panel was doused with sea water entering a broken porthole causing an actual or perceived panel malfunction. At the time of malfunction or when personnel attempted to correct the malfunction, the OCEAN RANGER either took water into the ballast tanks or water shifted to the forward tanks, or both, causing a list by the bow. At some point, the crew had taken the measure of closing the two manually operated sea inlet gate valves. Evidence indicates the rig may have had a 10 degree list for a period of time which the crew believed had stabilized. An approximate moment of 17,000 (F/LT) was required to cause a 10° trim by the bow.

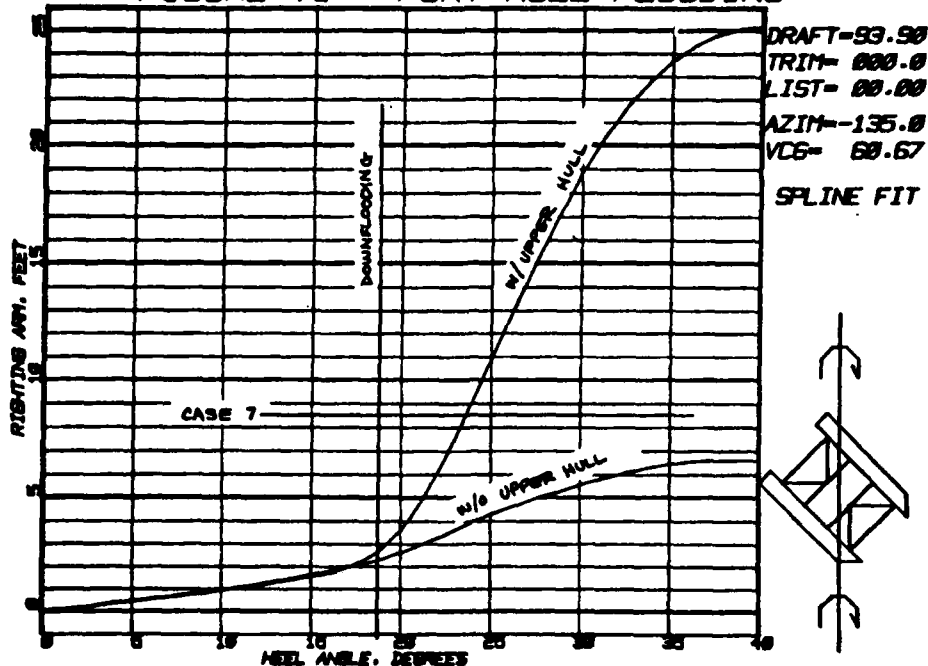
FIGURE VI - PORT HULL FLOODING

Task VI - Effect of Port Hull Flooding

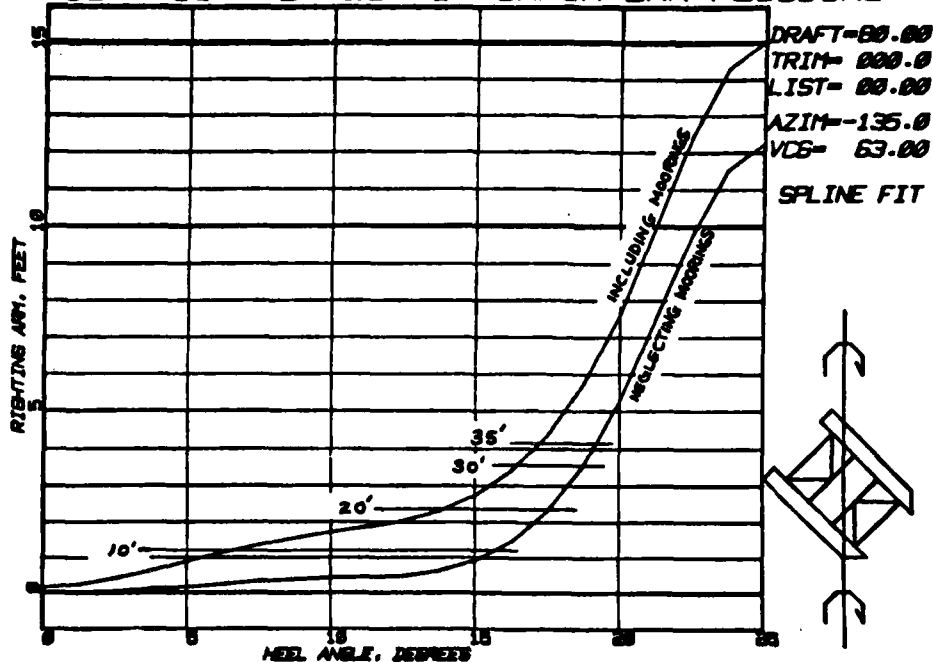
FIG. VII - EFFECT OF CHAIN LKR FLOODING

Task VII - Effect of Chain Locker Flooding

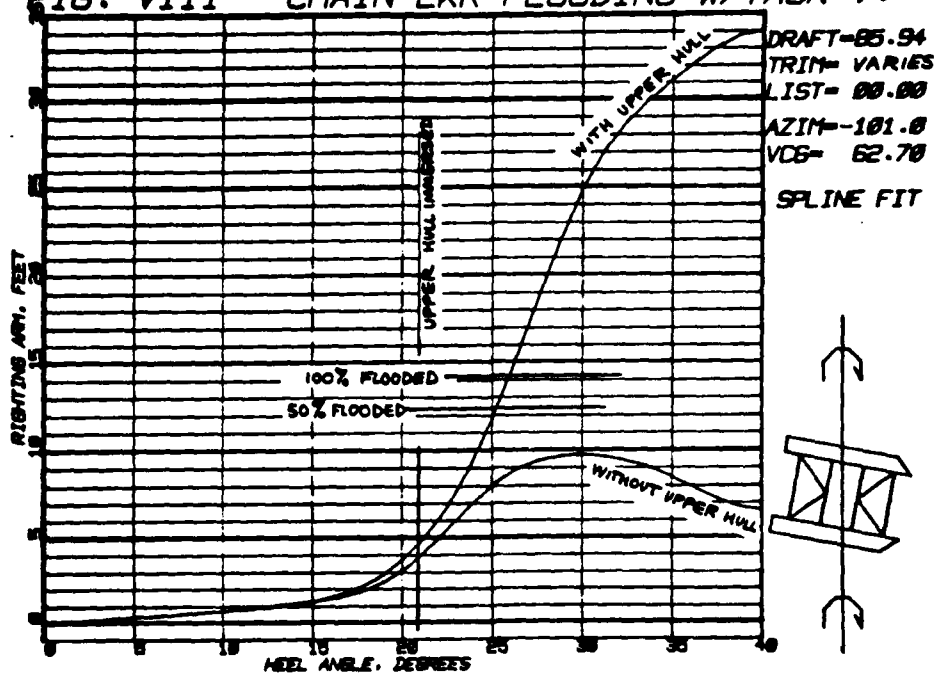
FIG. VIII - CHAIN LKR FLOODING W/TASK V.

Task VIII-Chain locker flooding combined with Case 1 of Task V.

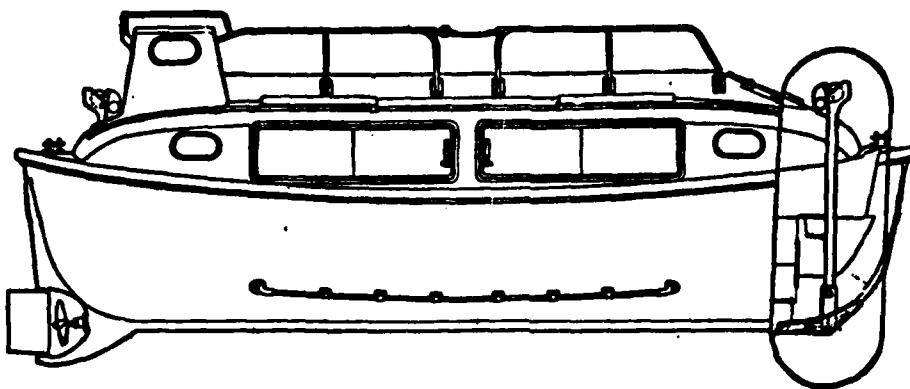
Figure 1. Harding 26 ft. totally enclosed lifeboat. Internal view at forward end shows release gear arrangement. The hook is attached to a support bar which is in turn attached to the keel shoe by a pin joint. The keel shoe is "glassed in" at the keel and is the means of transferring the load of the boat to the release gear. The support bar is held vertically by a flange bolted to the fiberglass at the point where the support bar penetrates the cover.

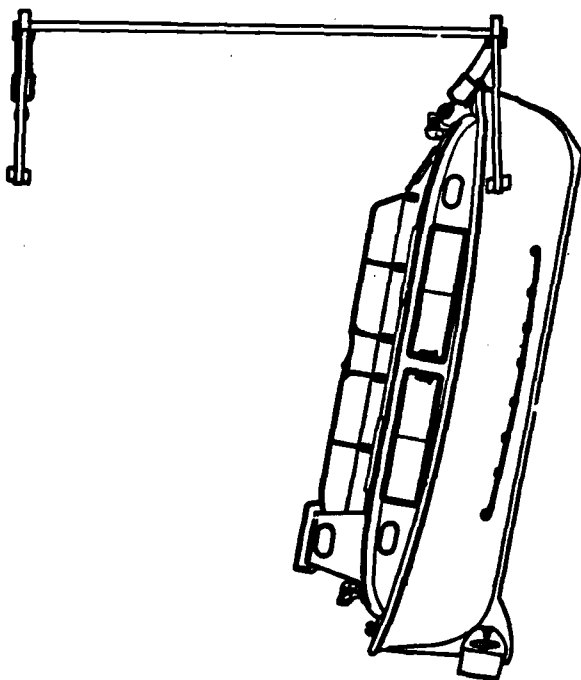
Figure 2b. Aft release hook has been opened, allowing aft end of boat to fall. Davit chocks at forward end normally in contact with gunwale dig into hull, leaving "L" shaped inward fractures on both sides of the hull.

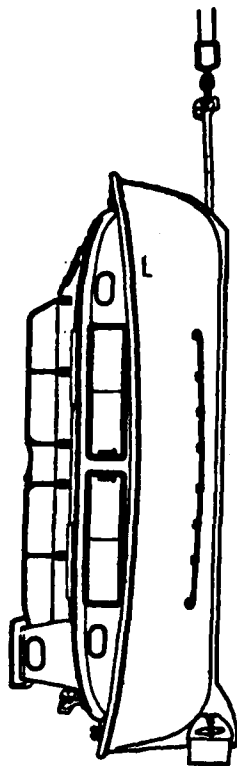
Figure 2c. (Davit omitted for clarity)
Release support bar connection to cover
is intended to stabilize the support bar
in the vertical position in normal
circumstances. It is unable to support
the boat hanging from one end, so it
pivots on the pin connecting it to the
keel shoe, ripping out the stem area of
the hull as it goes.

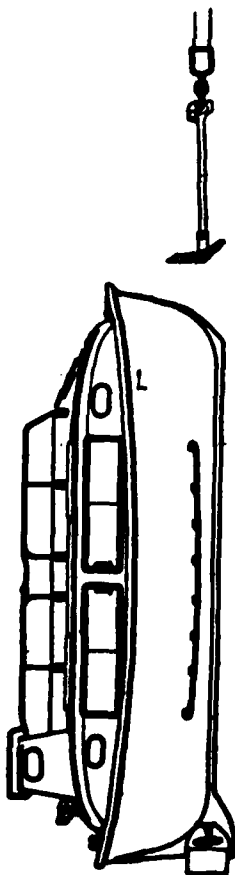
Figure 2d. The glassed in keel shoe is
unable to support the boat in this
position and is torn out, allowing the
release gear to separate from the boat
which enters the water stern first.

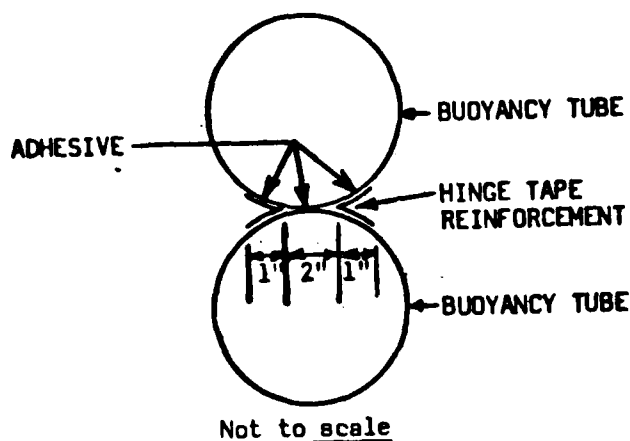
Figure 3. Normal construction of liferaft.

adhesive joining upper and lower tubes directly. Adhesive was evident only on the reinforcement. If the tubes are directly joined, forces tending to separate upper and lower tubes would be resisted by a tensile load on the adhesive joining the tubes. As built, the forces pulling the tubes apart are resisted by the reinforcing tape in the peel mode. If the tubes had been joined in the central area, the resulting structure may have been more resistant to separation.
